OHIO RIVER SHORELINE, PADUCAH, KENTUCKY (PADUCAH, KENTUCKY LOCAL FLOOD PROTECTION PROJECT)

Public Meeting
City of Paducah

Louisville District

8 November 2010

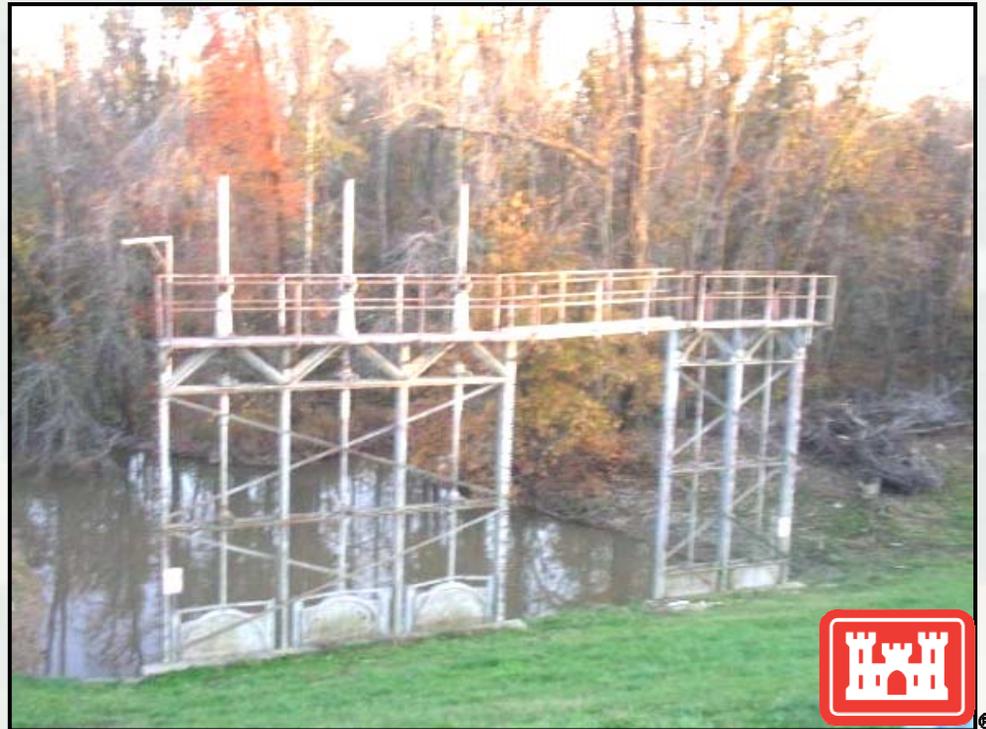
- ▶ **Example: Bee Branch sluice gate structure**

Access - Boat is required to reach closure

Structural Integrity – Deterioration of load bearing components and connections

Work Area – Limited

Safety – Ladder, catwalk and hand-railing do not meet safety standards

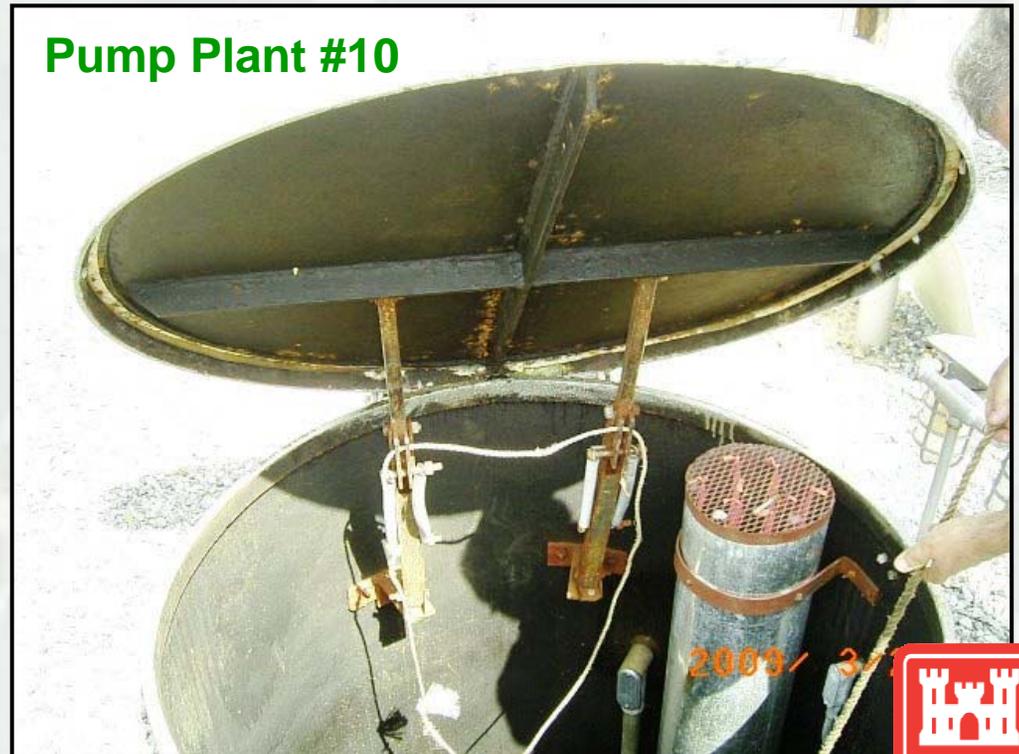
Pump Plant #10

Access – Exceptionally confined working space

Safety – Ladder access unusable requiring tripod/lanyard entry

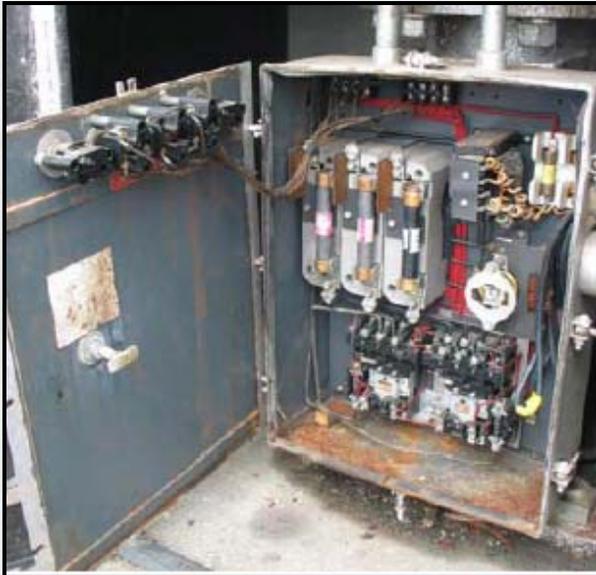
Gate Control Interior
Poor Condition

- ▶ Pump motor controls and motor control centers – need to be replaced due to age and components are obsolete. Manufacturers do not keep spare parts on aged equipment
- ▶ More expensive to rebuild in most cases than purchase new
- ▶ No backup emergency power – Adding capability to connect portable generators

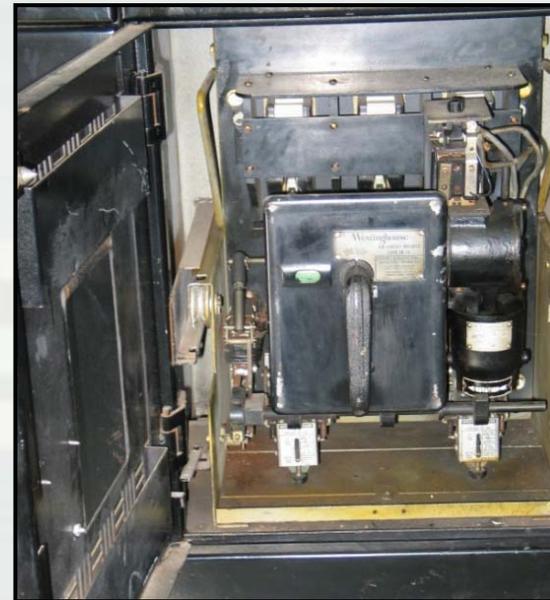
Circuit Breaker used as Motor Starter
Obsolete Method and Equipment

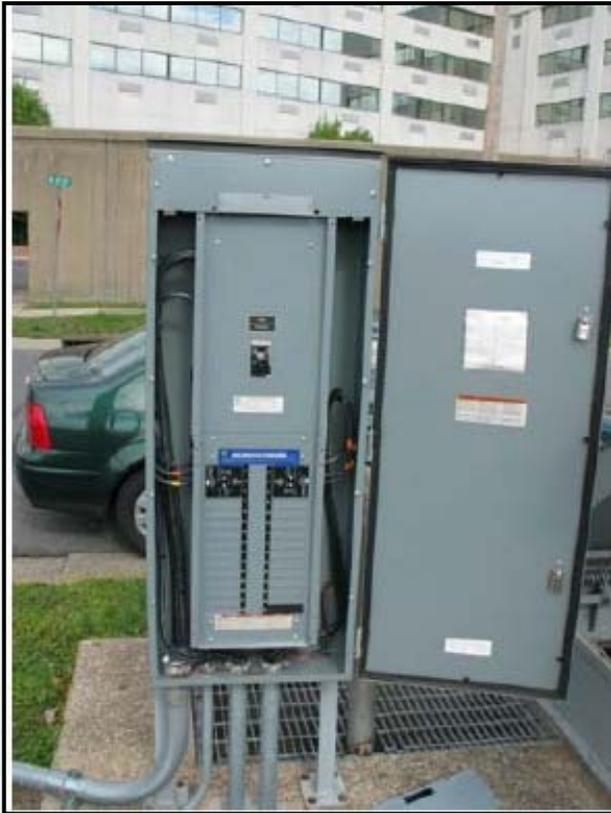
**New Outdoor Panel – Pump Plant Power
PP #4**

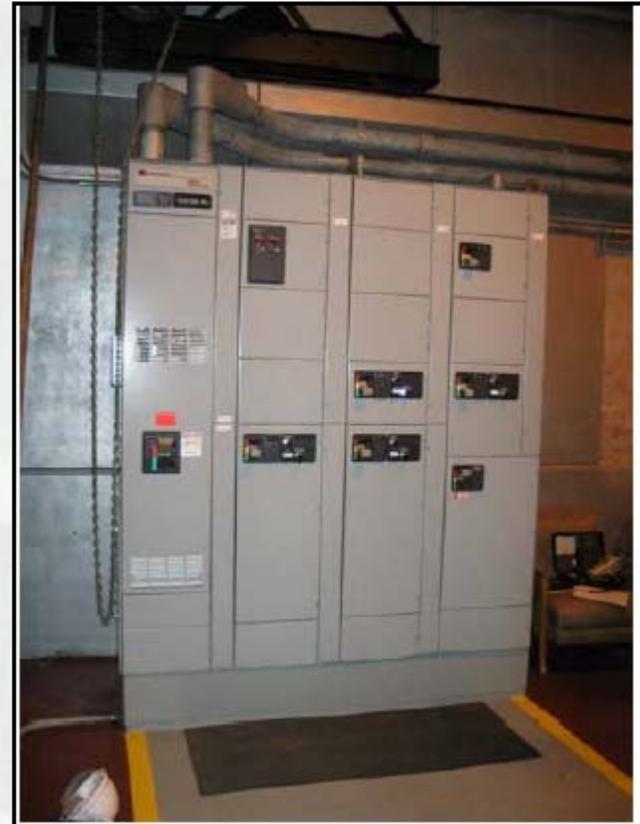
**New Motor Control Center
PP #6**

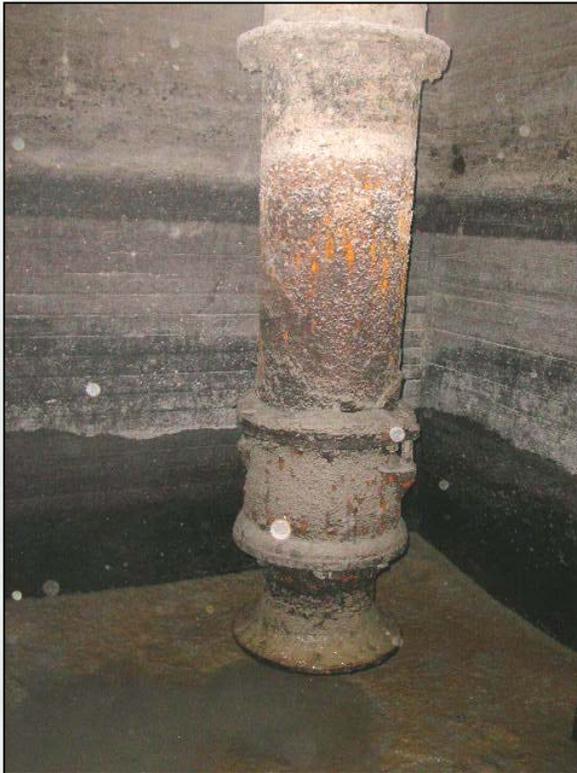
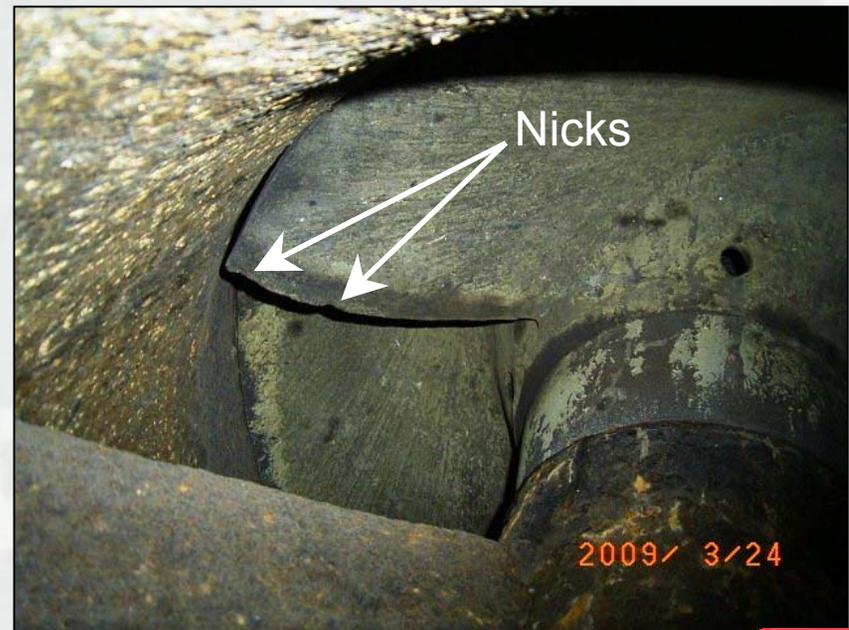
- Pumps have exceeded their life expectancy (60 years in operation vs. 35 year current minimum design life)
- Some pumps being replaced with submersibles pumps that are removable and do not require confined space entry

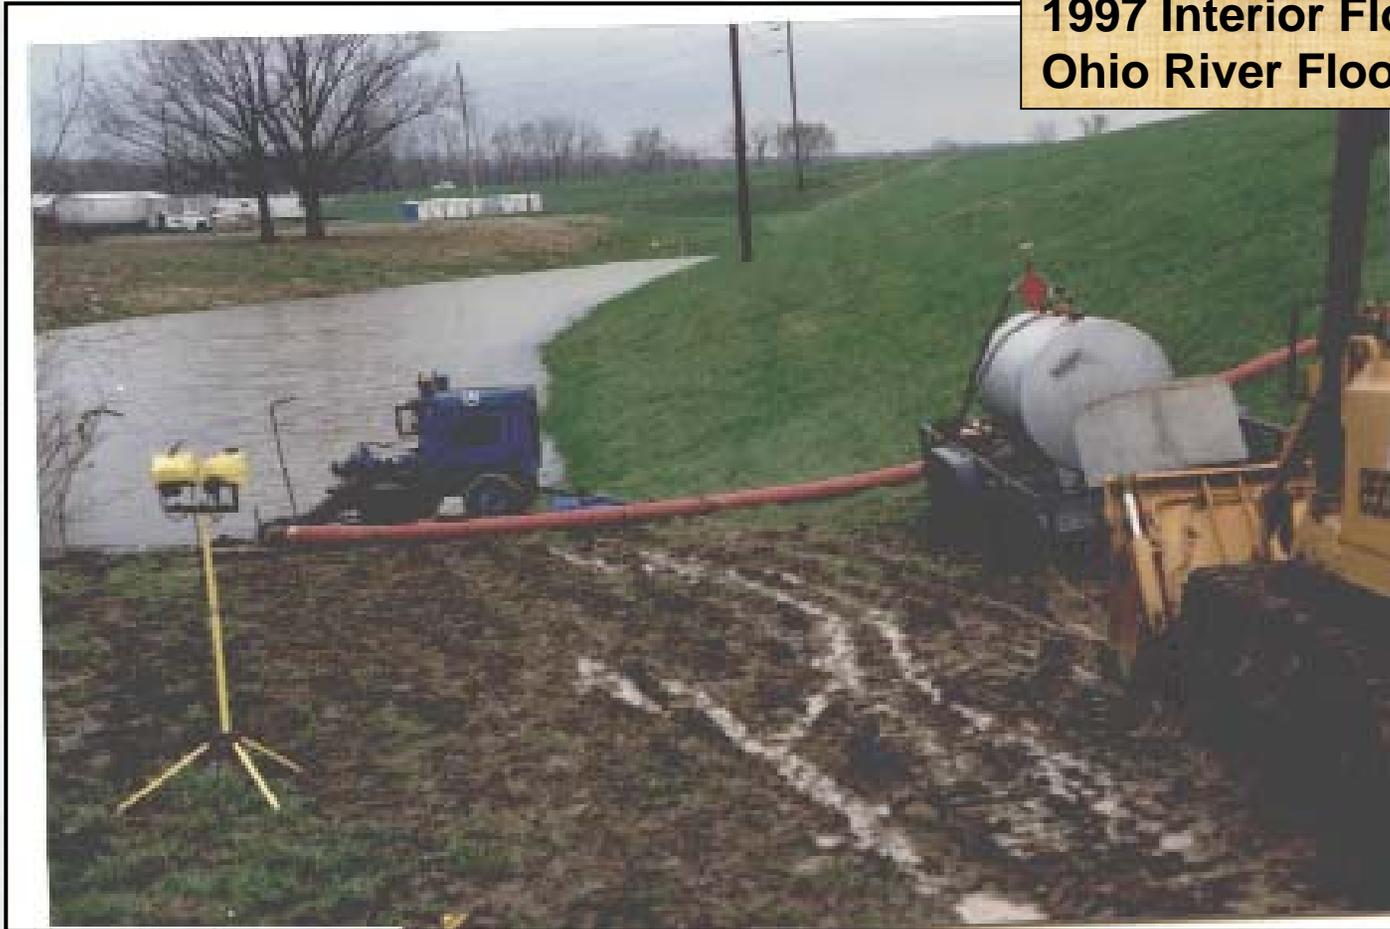
4 Structures/Properties Flooded during 1997 Event

**1997 Interior Flooding
Ohio River Flood = 60yr**

New Pump Plant #14a – Sta. 111+67A (2300 North 8th St)

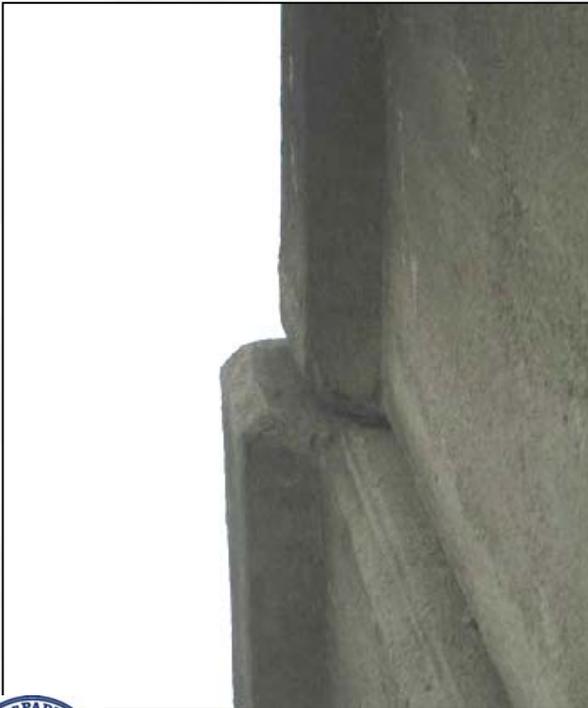
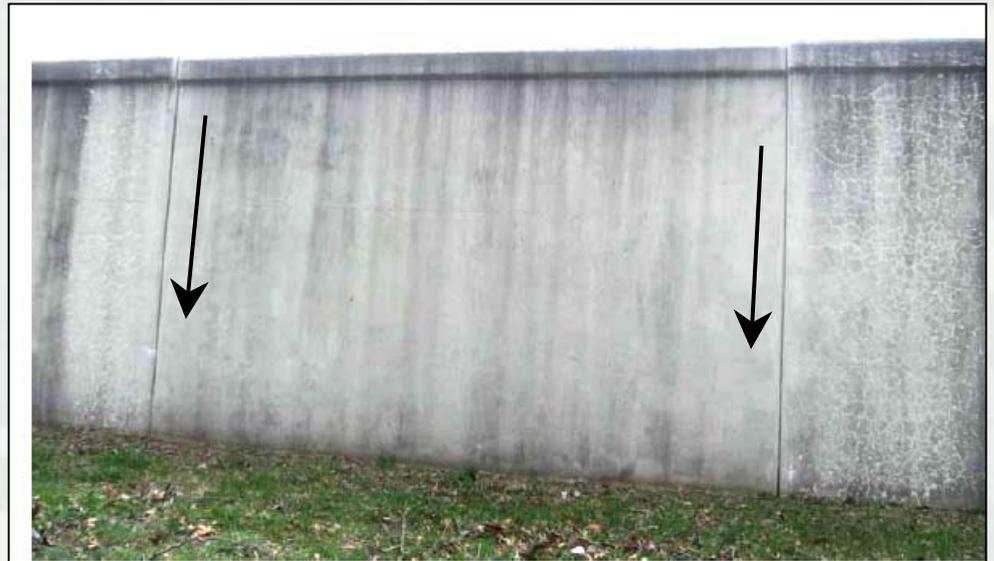
- Differential Wall Movement caused damage to waterstops

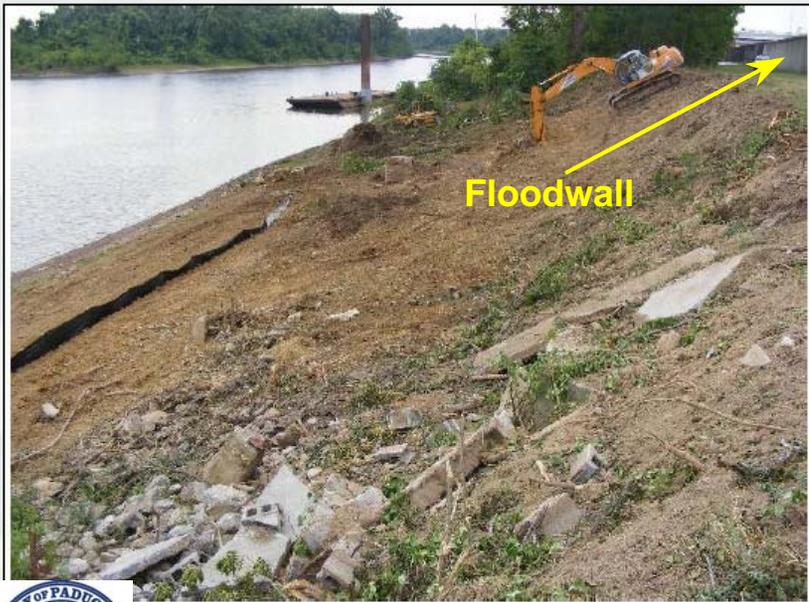
- Bank Erosion (within 10 feet of heel of floodwall) - Threatening Stability of T-Walls

Before Riverbank Repair

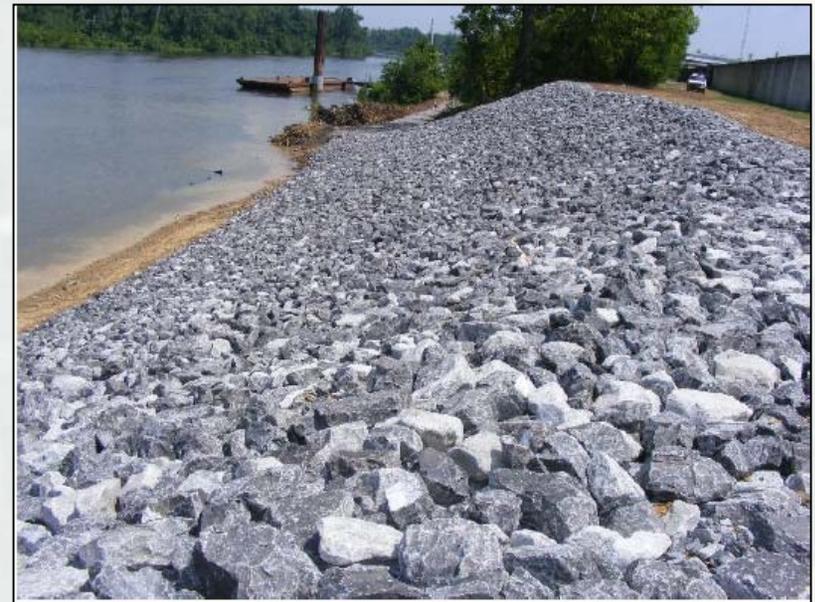
After Riverbank Repair

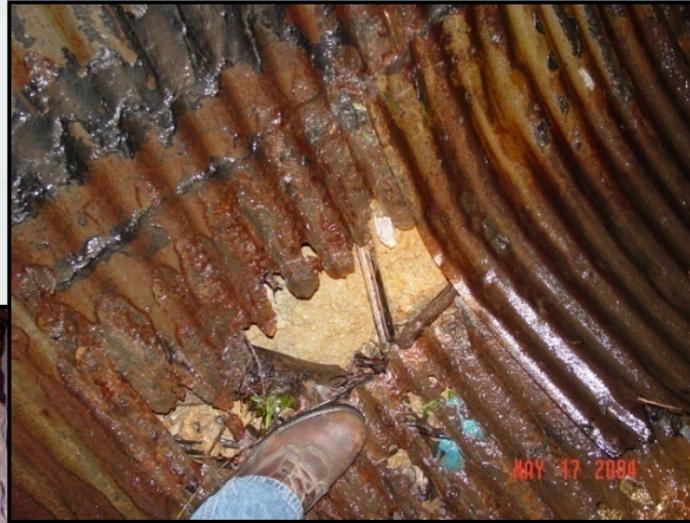
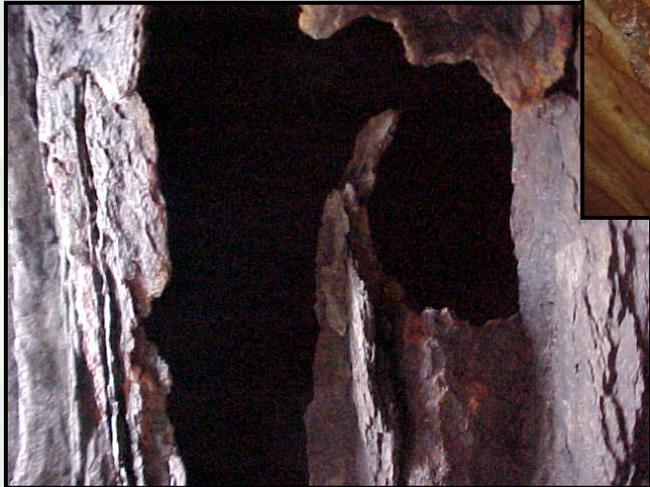
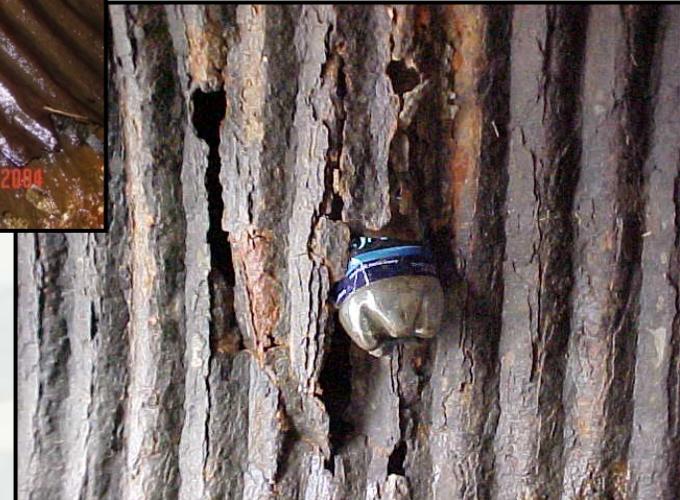
Deteriorating Corrugated Metal Drainage Pipes:

- Pipes video inspected for condition assessments and rated per National Industry Standard – ratings in November 2008 revealed pipes in imminent failure

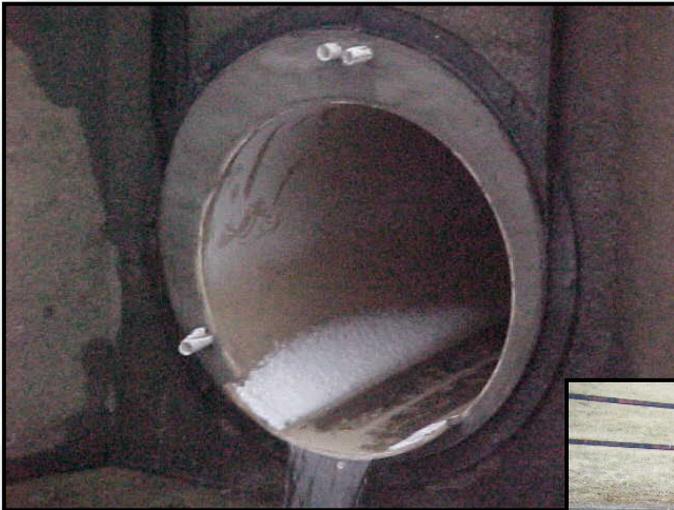
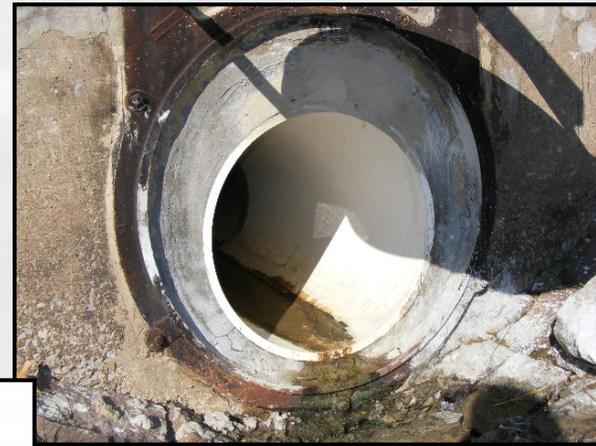
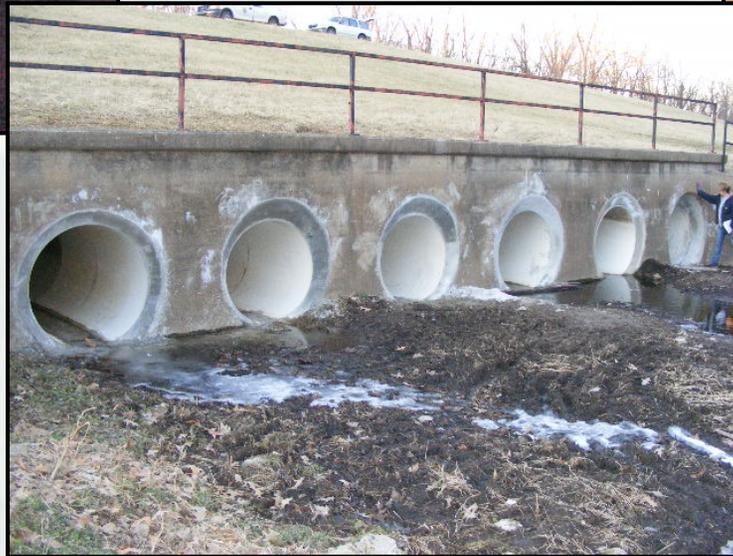
Slip lined 37 Deteriorated Pipes:

- Sponsor Completed Repairs – January 2010
